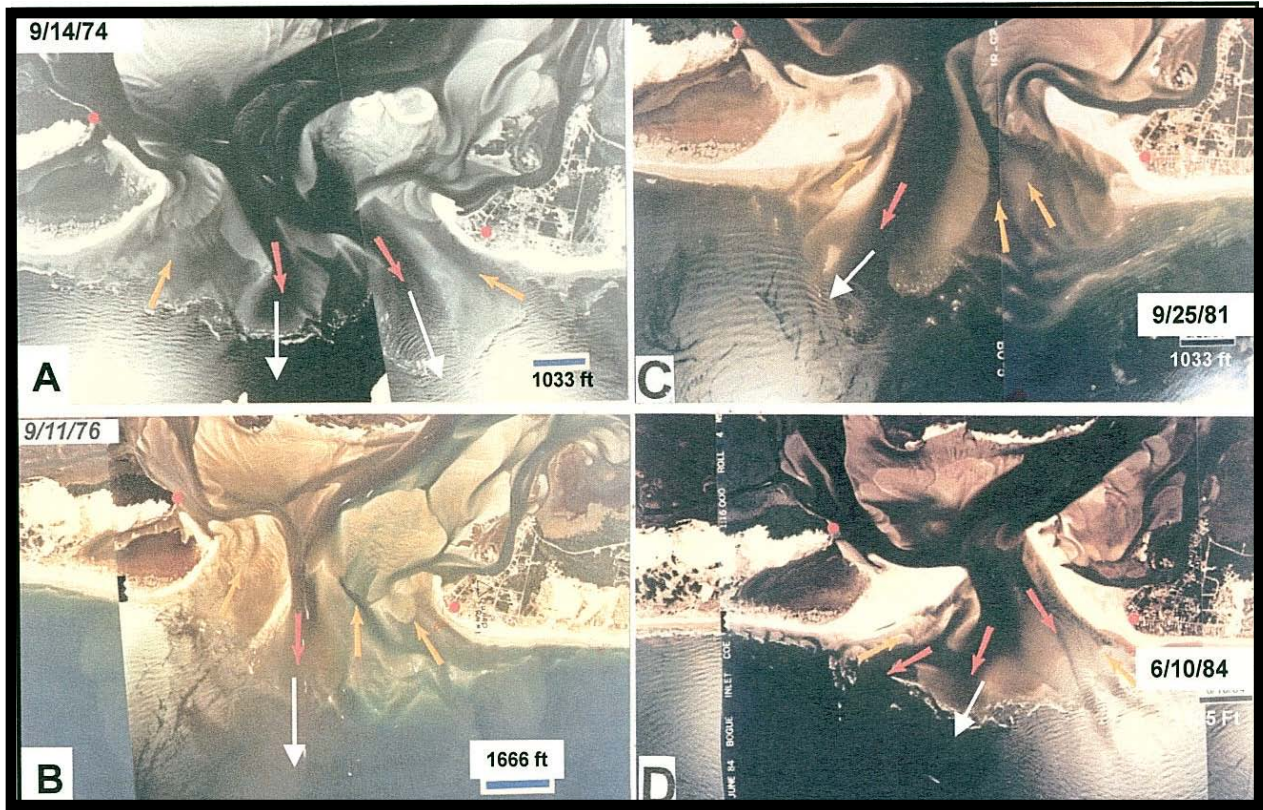
Figure 4.1 Historic aerial photographs September 1974 to June 1984 depicting inlet and shoulder configurations.

(Note: Two ebb channels present in 1974 merged into a single channel by 1976; Spit elongation on adjacent shoulders.)
